SUBJECT: PILOT STUDY JULY 2009 EVALUATION
LOWER SILVER CREEK TAILINGS SITE
WORK ASSIGNMENT No. 0-300
TRIP REPORT

This trip report summarizes the start up of a pilot scale study at the Lower Silver Creek Tailings Site initiated on May 11, 2009. In November of 2008, Lockheed Martin Response Engineering Analytical Contract (REAC) personnel were tasked to chemically and agriculturally characterize soil provided from the site. Part of this evaluation was to determine the effect of a locally available biosolids compost source and another organic compost on the soil chemistry and plant growth in these soils. Contaminated soil (tailings) cover a large area of the site, and an effective way to revegetate the area and/or bind metals of interest would be more economic than removal. The current goal is to observe the effects of the amendment in the field *in situ*, and to compare different amendments and amendment application rates on the growth and long term establishment of native vegetation.

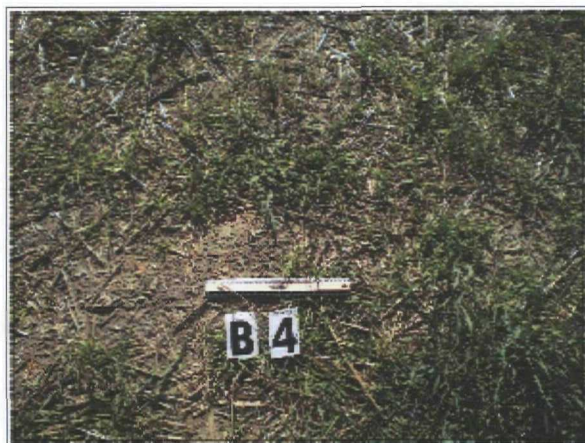
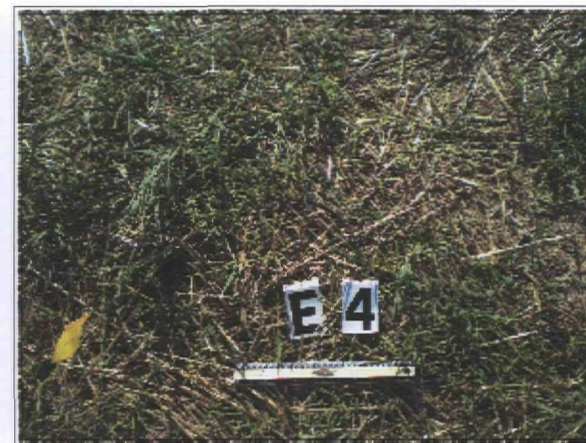
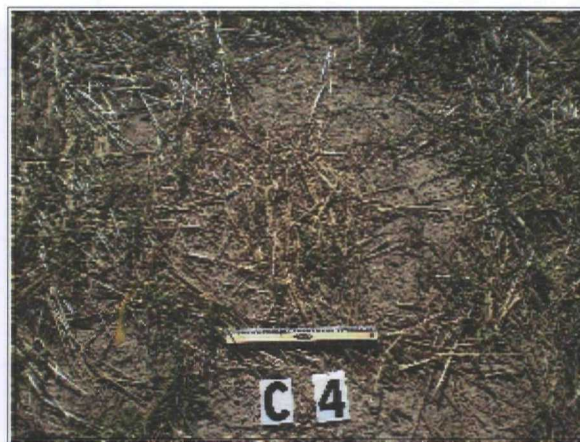
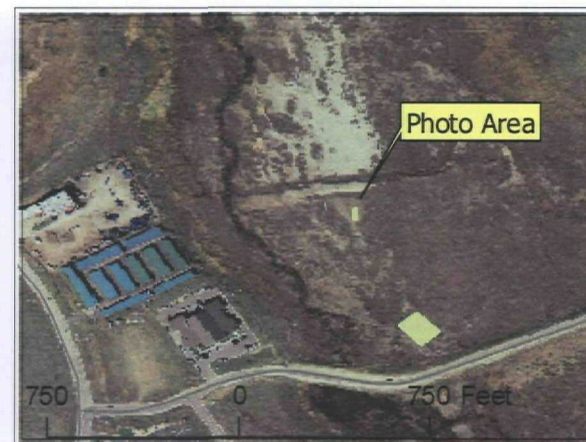
Photos taken July 8, 2009 - 7 weeks after seeding.

REAC personnel arrived at the site on the afternoon of Wednesday, July 8, 2009. Overall condition of the site was excellent. Fencing was intact, straw mulch was still evenly distributed, and germination and growth of the seed mixtures was readily visible even from the road. In addition, differences in growth of the different treatments was readily apparent (Figures 1 and 2, Table 1), both from the road and at close inspection. Vegetative growth was very good with certain treatments even on the small plot of previously barren tailings (Figure 2). Initial observations suggest that the tailings will support relatively normal plant growth after the addition of an organic amendment. Additional study is needed to see if the plant growth continues to remain dense after multiple growing seasons, if plant species diversity is maintained, and the effect of growing plants and organic amendments on the mobility of the metals on site.
